Case No. 14-CR-00175-WHA

**DECLARATION OF [REDACTED] IN
SUPPORT OF RESPONSE TO ORDER
REQUESTING INFORMATION ON
DIXIE AND BADER FIRES**

8 3. I have reviewed the electronic data files provided to me by [REDACTED], Senior
9 Manager of PG&E’s Distribution Planning Group. [REDACTED] advised me that these files were
10 downloaded on July 21, 2021 from the electronic controller on the Cooper line recloser located at
11 the substation for PG&E’s Bucks Creek 1101 12kV Line. I reviewed these data files using
12 Cooper Proview 5.0 software.

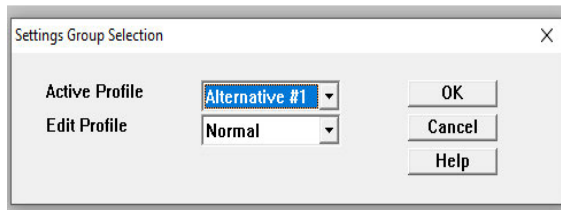
17 5. The following is a true and correct screenshot of the setting group selector data in
18 the “bucks creek 1101_2_asfound_07212021.f6s” file:

23 This data shows that “Alternative #1” was the active setting group profile when the “bucks creek
24 1101_2_asfound_07212021.f6s” file was downloaded on July 21, 2021.

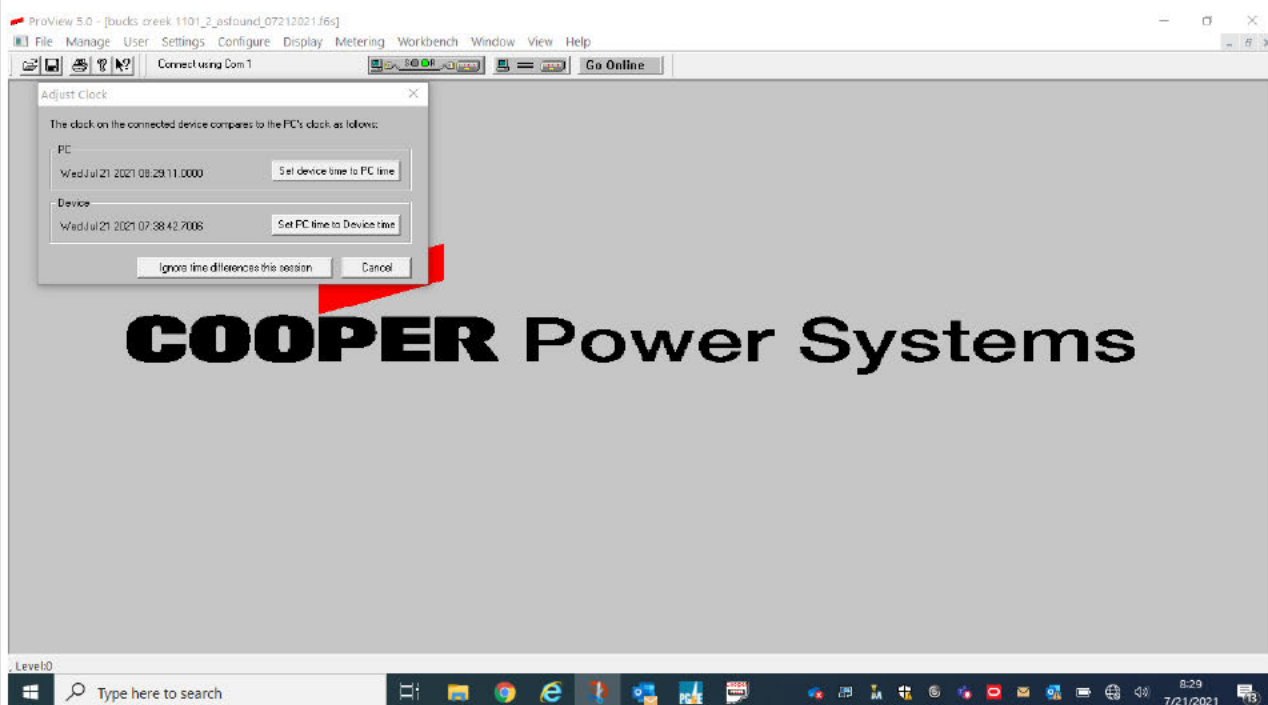
11. The file name indicates that current in excess of the “minimum to trip” was detected at 5:57:18.414 on July 13, 2021 as reported by the line recloser’s internal clock. However, I received from [REDACTED] the following screen shot which he advises was taken at the time the data I reviewed was downloaded from the line recloser:

This shows that the internal clock on the recloser is running 50 minutes and 28.3 seconds behind the time reported by the internal clock on the laptop used to download the data. Adjusting for this fact would make the time when the current exceeded the “minimum to trip” approximately 6:47:46.714 a.m. on July 13, 2021.

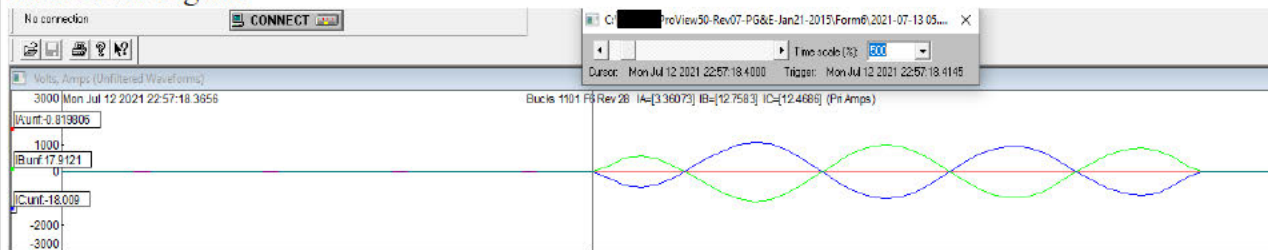
12. The event file contains the recorded oscillography data for that phase to phase fault event. The following is a true and correct screen shot reflecting the time and amperage recorded in the oscillography data when I placed my cursor at the time interval where the phase to phase fault event begins:

This indicates that the phase to phase fault event involved just two of the three phases and began at approximately 22:57:18.4000 on July 12, 2021. The oscillography, however, uses Coordinated Universal Time (“UTC”), which is seven hours behind Pacific Daylight Time. Adjusting for this fact and for the difference between the internal clock of the line recloser and the internal clock on the laptop downloading the data would make the time when the current exceeded the “minimum to trip” approximately 6:47:46.7000 a.m. on July 13, 2021.

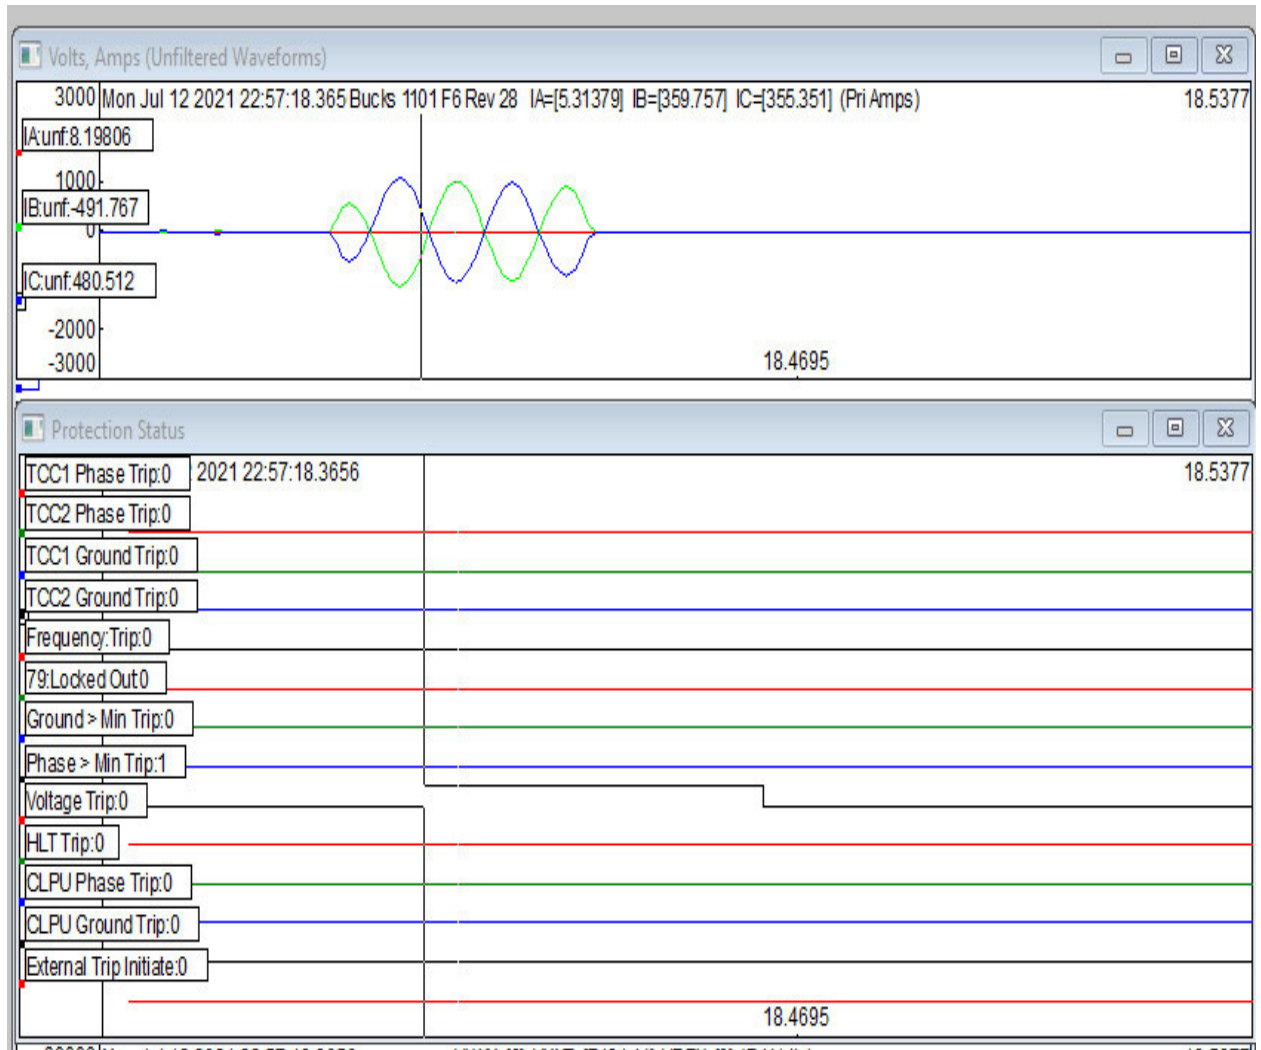
13. The following is a true and correct screen shot reflecting the time and amperage recorded in the oscillography data when I placed my cursor at the time interval when the above “minimum to trip” element in the controller asserts:

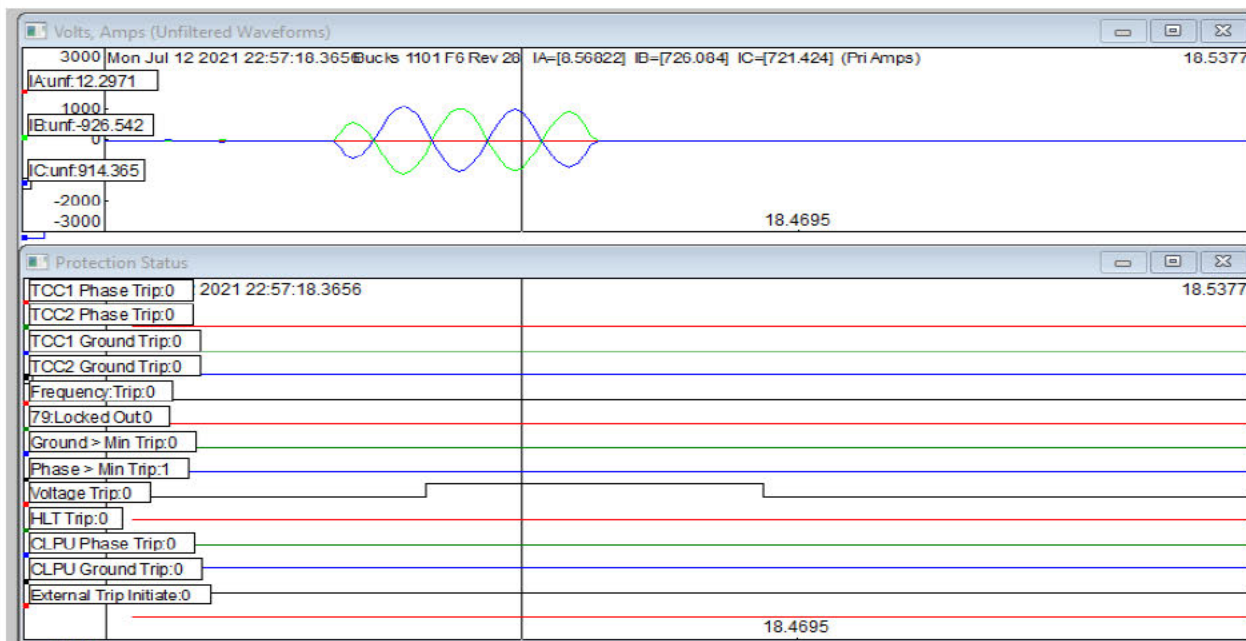
14. The following is a true and correct screen shot reflecting the time and amperage recorded in the oscillography data when I placed my cursor at the time interval when the amperage in the phase to phase fault event is at its maximum:

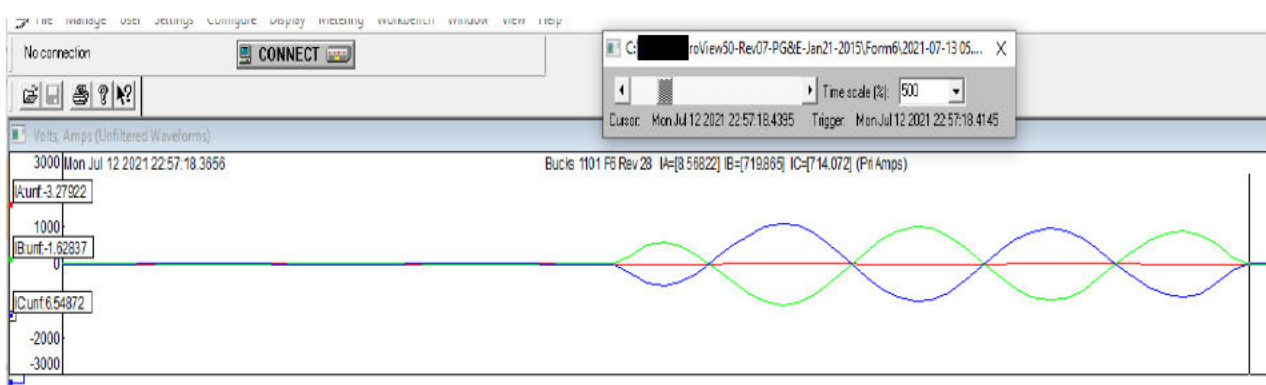
15. The following is a true and correct screen shot reflecting the time and amperage recorded in the oscillography data when I placed my cursor at the time interval where the phase to phase fault event ends:

This indicates that the phase to phase fault event ended at approximately 22:57:18.4395 on July 12, 2021. The oscillography, however, uses Coordinated Universal Time ("UTC"), which is seven hours behind Pacific Daylight Time. Adjusting for this fact and for the difference between the internal clock of the line recloser and the internal clock on the laptop downloading the data would

1 make the time when the current exceeded the “minimum to trip” approximately 6:47:46.7395 a.m.
 2 on July 13, 2021 (0.0395 seconds after it began).

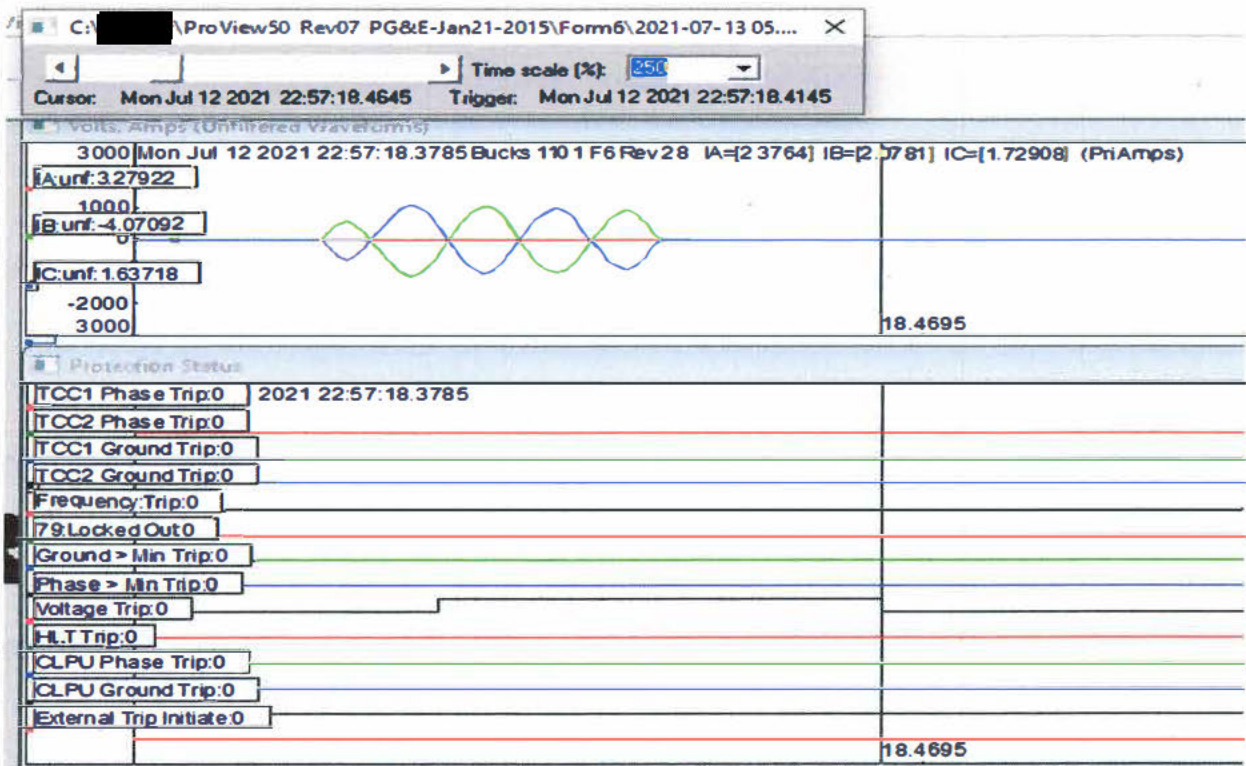
3 16. The following is a true and correct screen shot reflecting the time and amperage recorded
 4 in the oscillography data when I placed my cursor at the time interval when the above “minimum
 5 to trip” element in the controller de-asserts:
